# JEM446

## ŞEHİR PLANLAMASINDA JEOLojİ

Ders Notları 10.Hafta  
Depremsellik

Dr. Koray ULAMIŞ

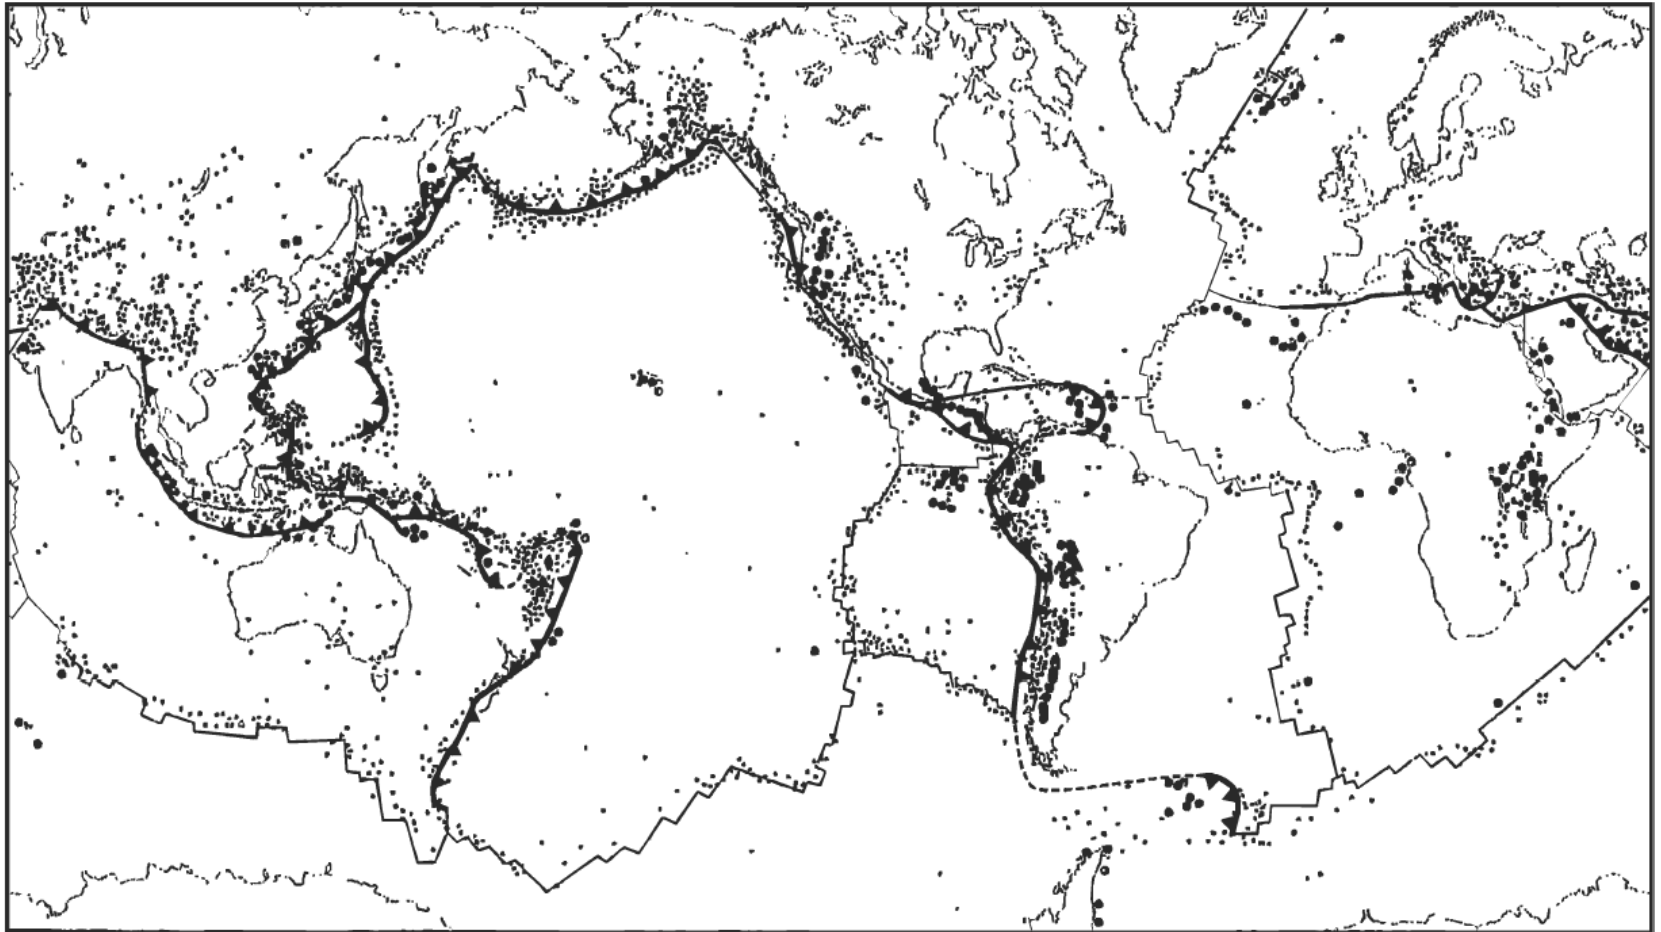
FIGURE 2.2 The major tectonic plate margins (heavy lines) and sample of most active seismic areas (heavy and light dots). Subduction zones marked with triangles (down dip).

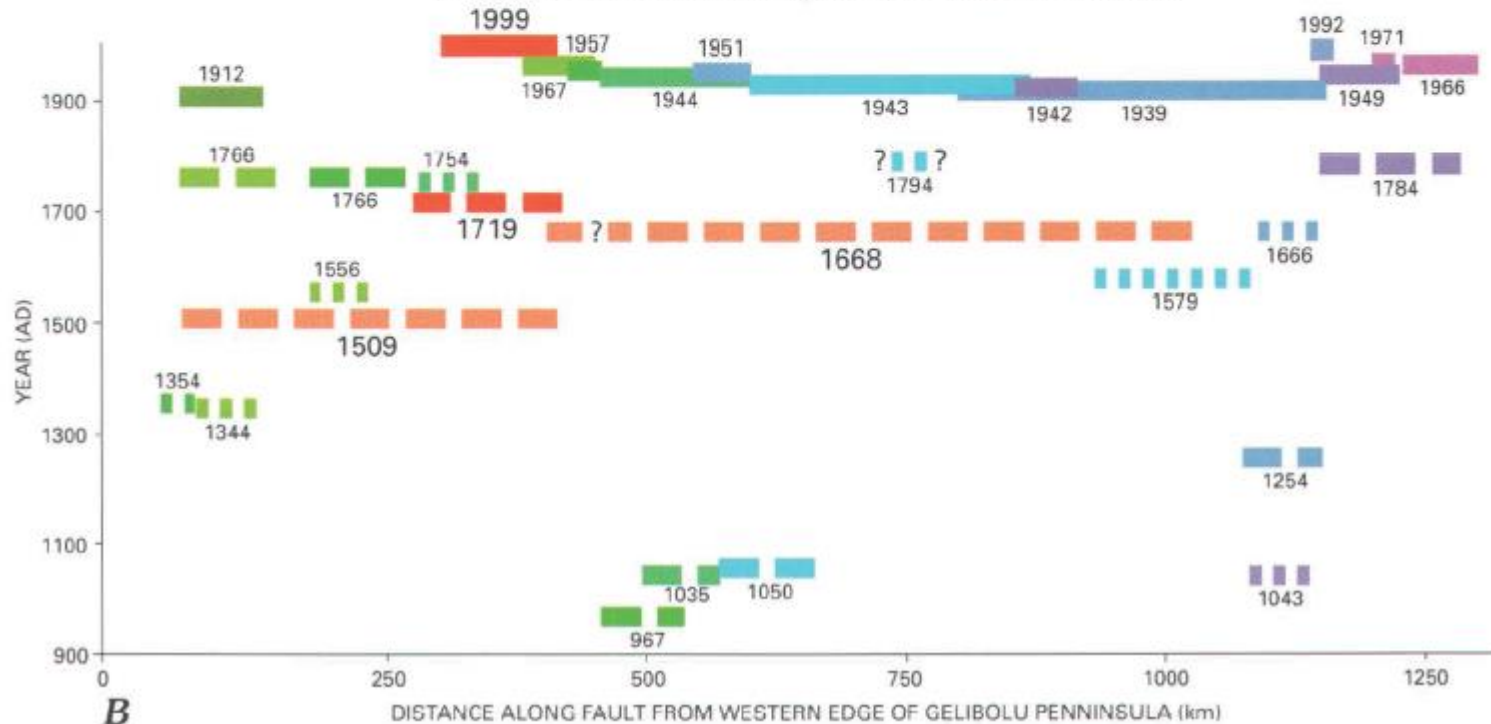
B

## Historic Earthquakes Along the North Anatolian Fault

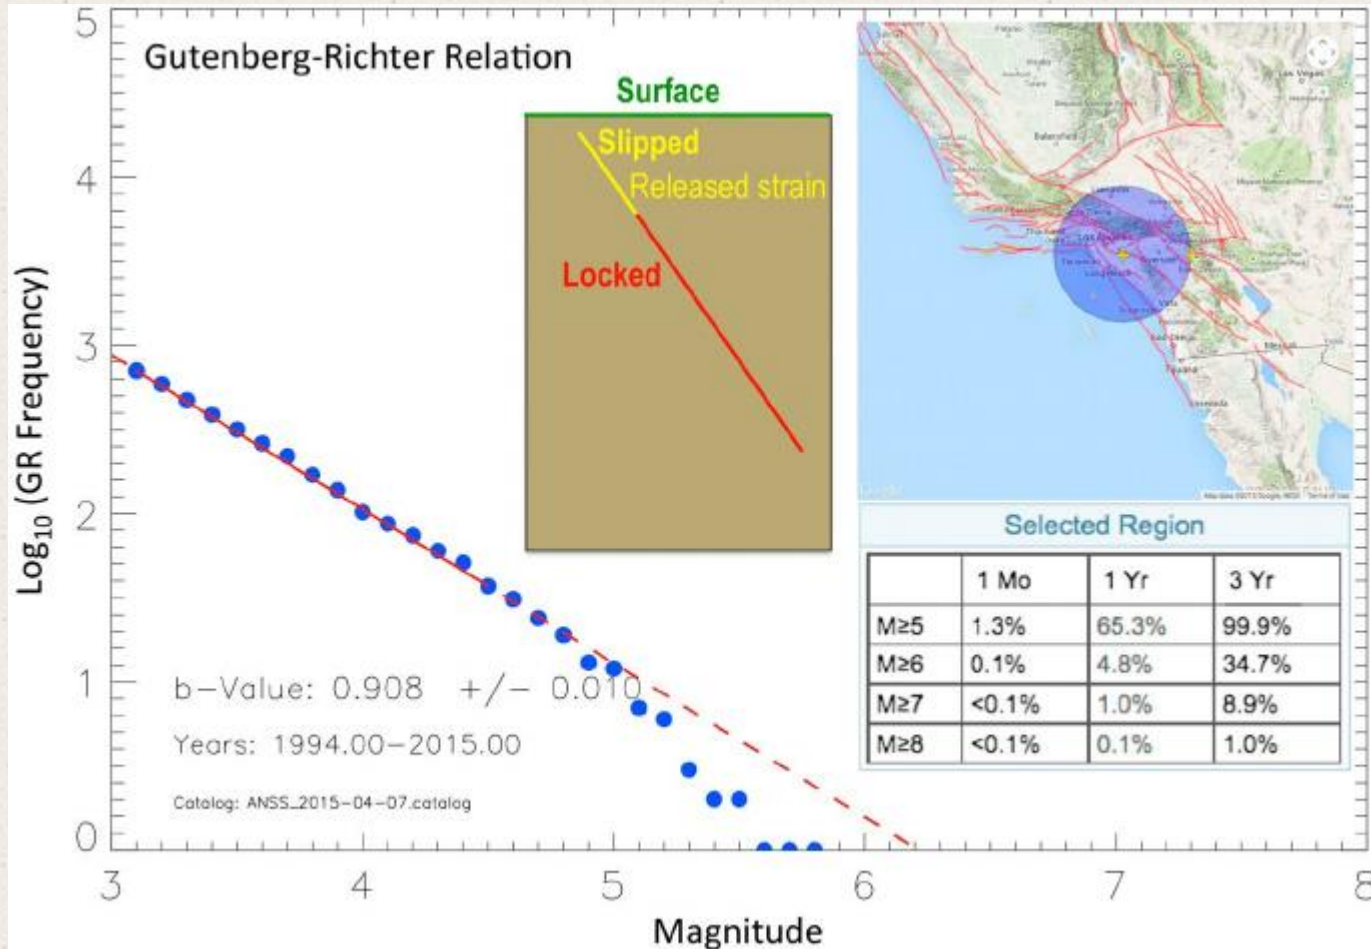
## 1. Gutenberg-Richter ilişkisi

$$\log N = a - bM$$

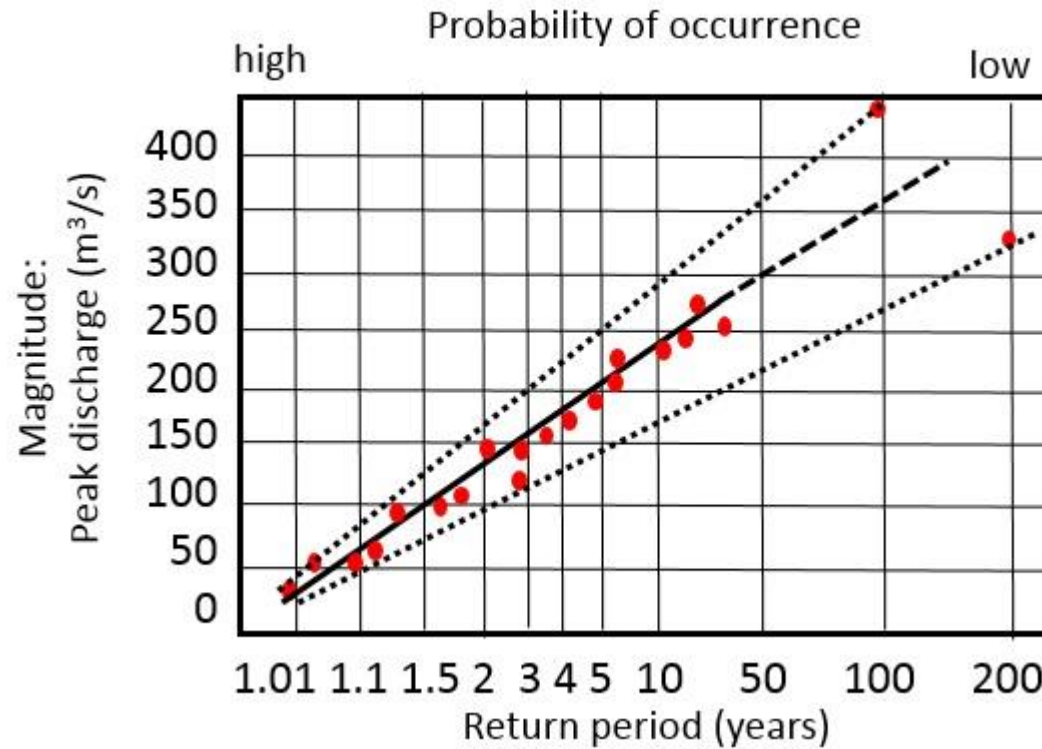
## 2. Belli büyüklükteki depremin tekrarlanma aralığı (Return Period)

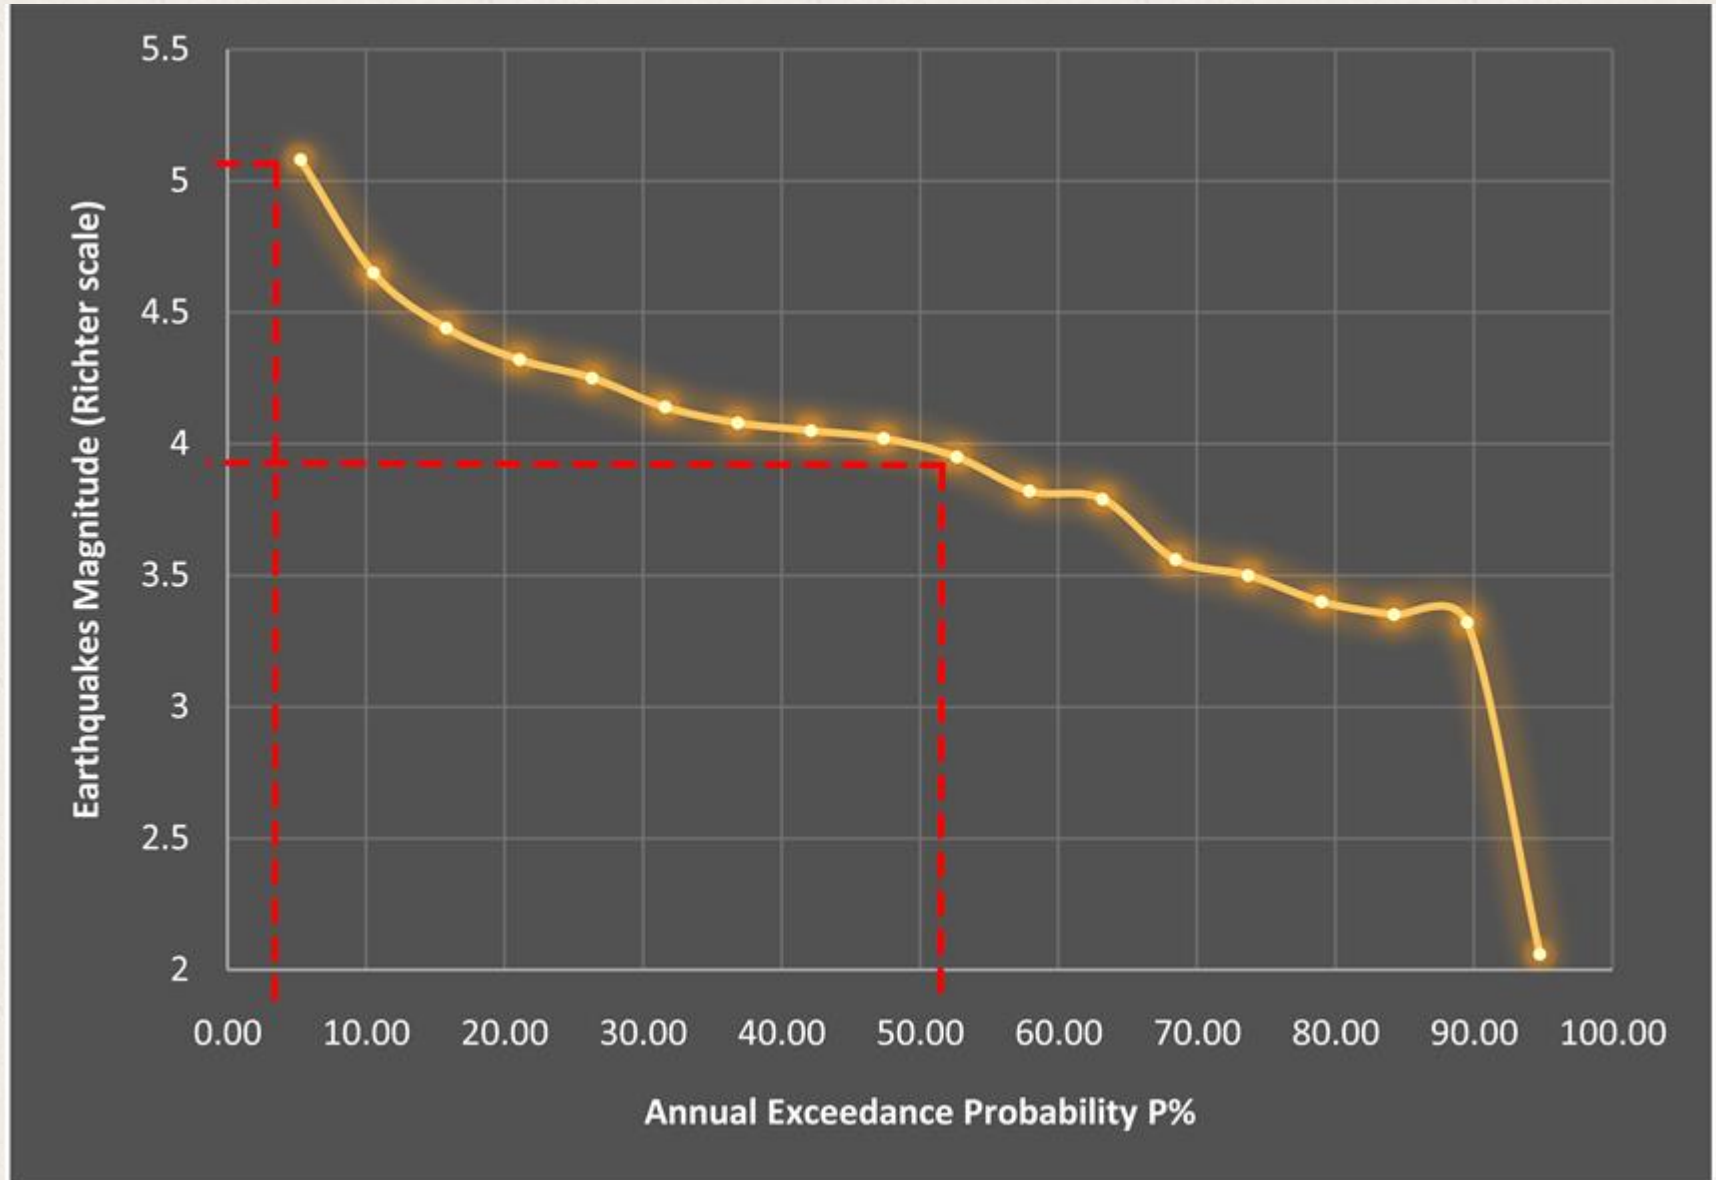
### 3. Limit değerlerin aşılma olasılığı (Probability of Exceedance)

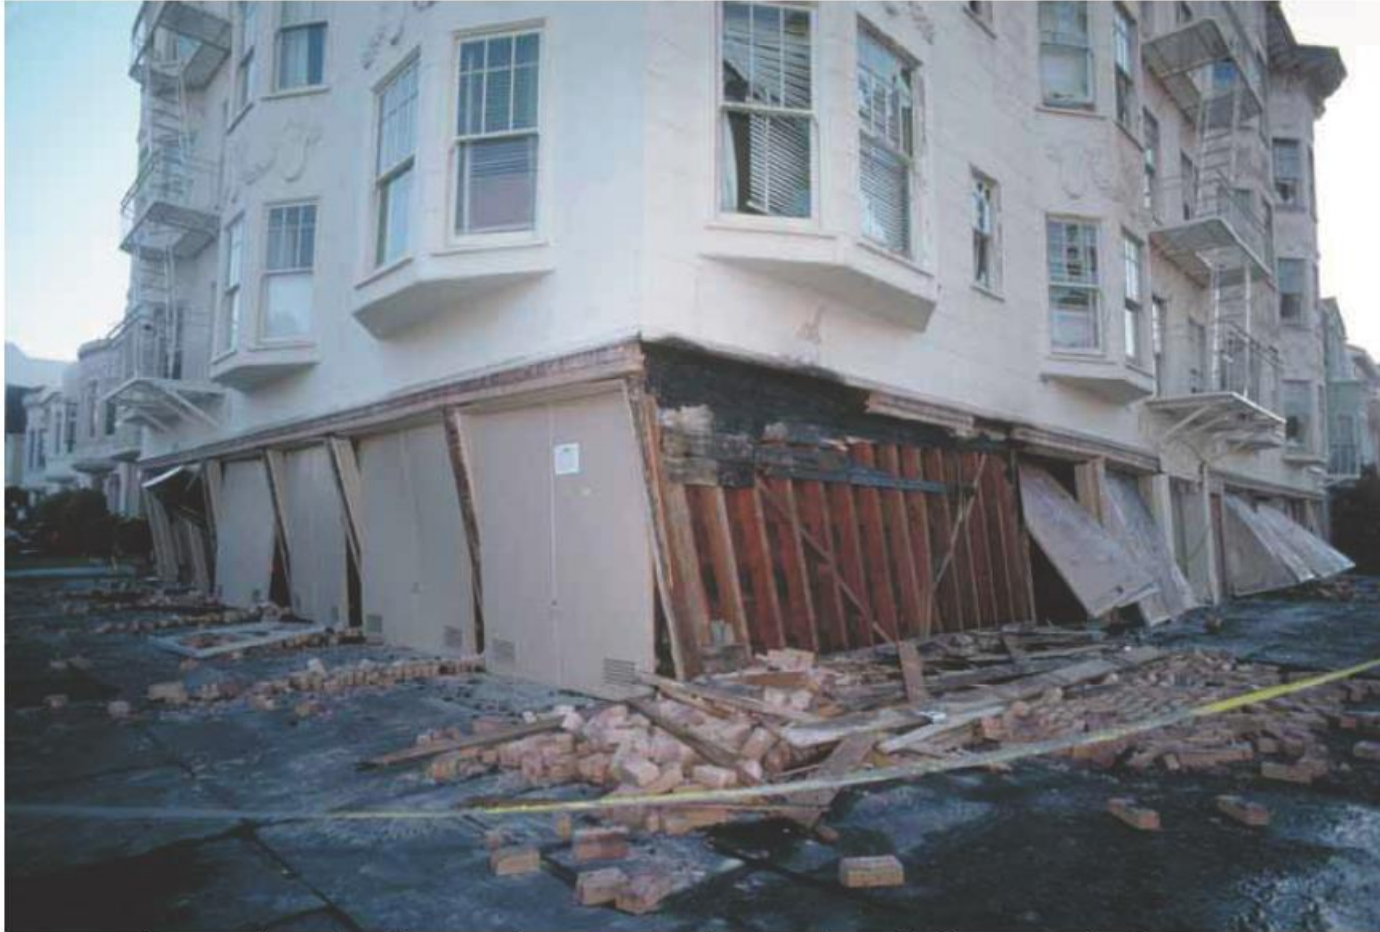
Loma Prieta earthquake damage in San Francisco. The soft first story is due to construction of garages in the first story and resultant reduction in shear strength. (Photo from: <http://earthquake.usgs.gov/bytopic/photos.html>)

Yumuşak kat ve makaslama deformasyonu

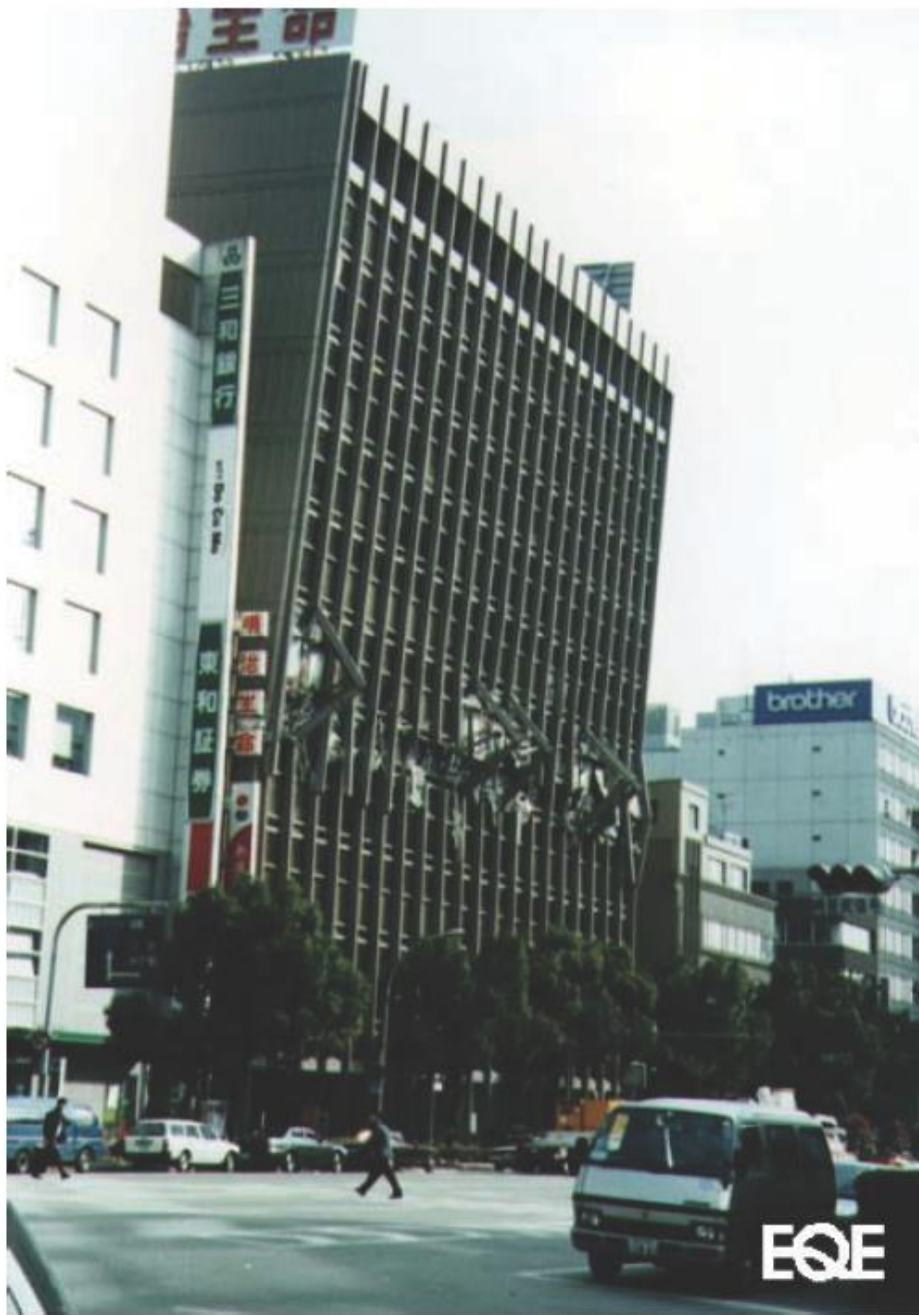
## Zayıf kat/kolon Makaslama

Mid-story collapse, Kobe earthquake. (Photo from: The January 17, 1995 Kobe Earthquake: An EQE Summary Report. April 1995, <http://www.eqe.com/publications/kobe/kobe.htm>)

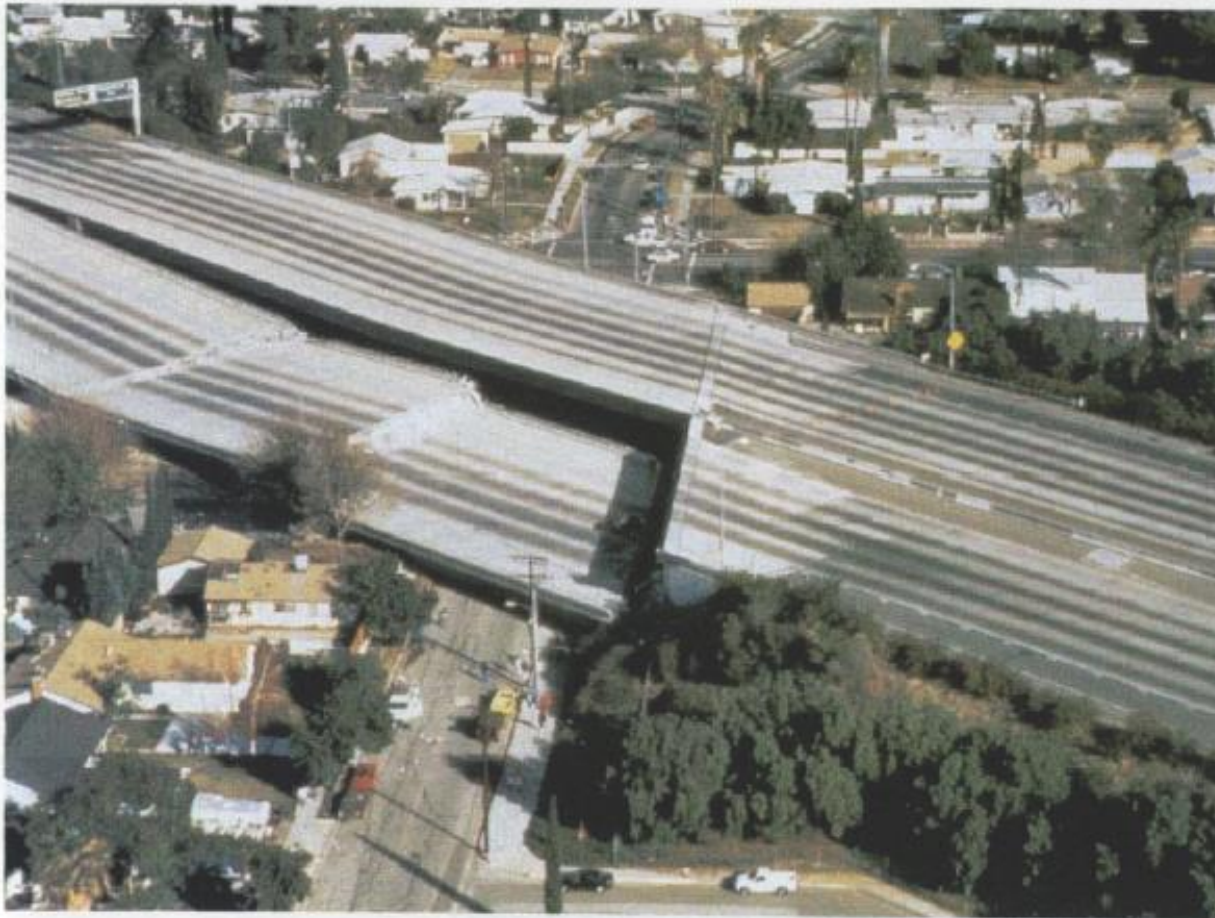
*Collapsed section of I-10 (Santa Monica freeway), West Los Angeles. The freeway had been built across relatively soft soils (drained wetlands), the probable reason for the structural failure. This section of freeway was repaired and made serviceable in three months time. Photograph by Kerry Sieh.*

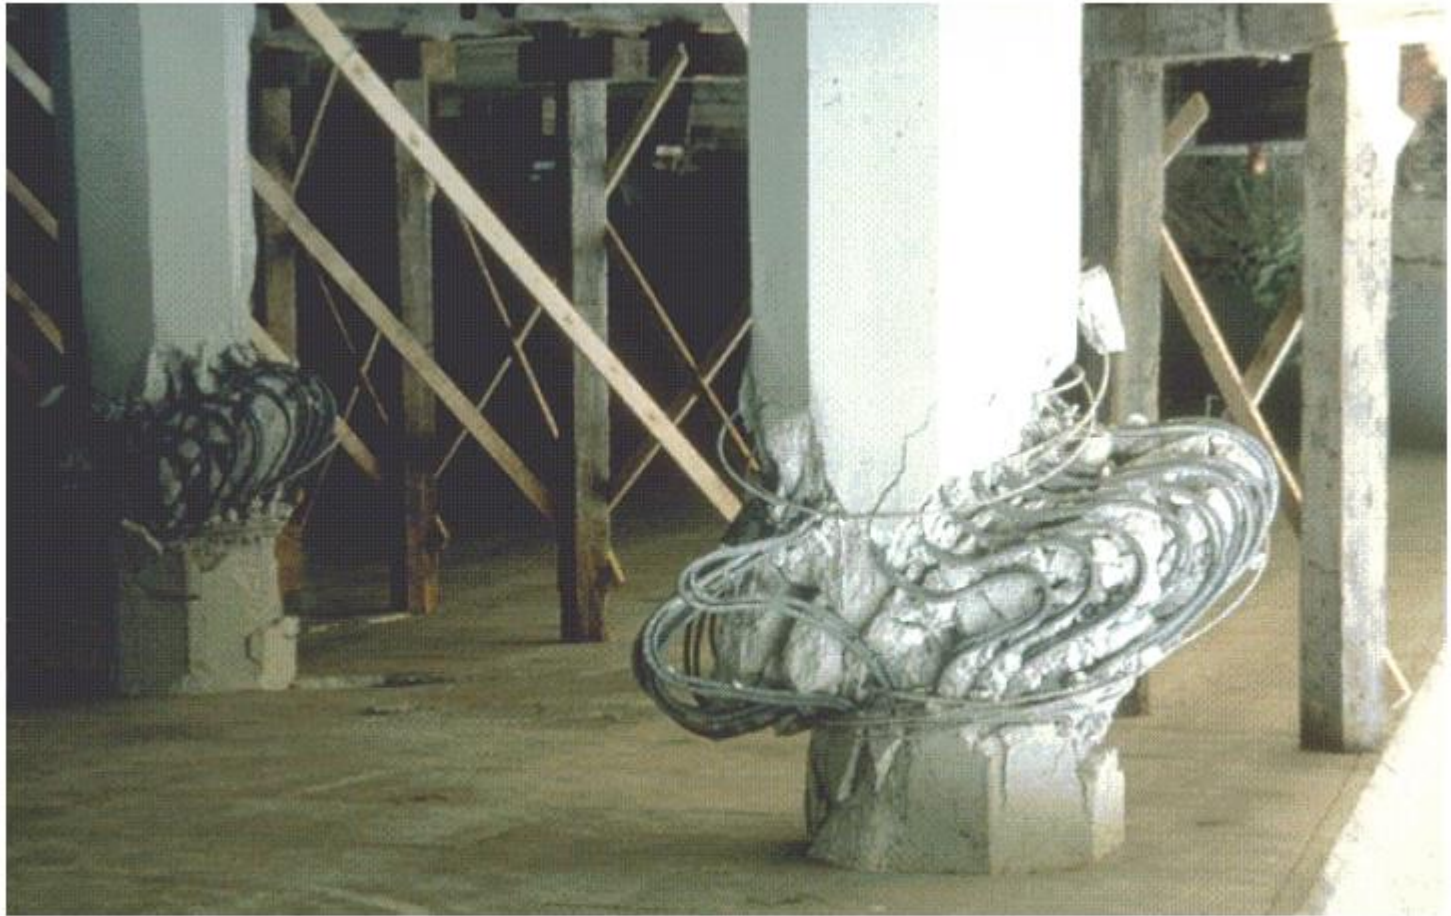
Column failure on interstate highway overpass, Northridge earthquake. (Photo from: <http://earthquake.usgs.gov/bytopic/photos.html>)

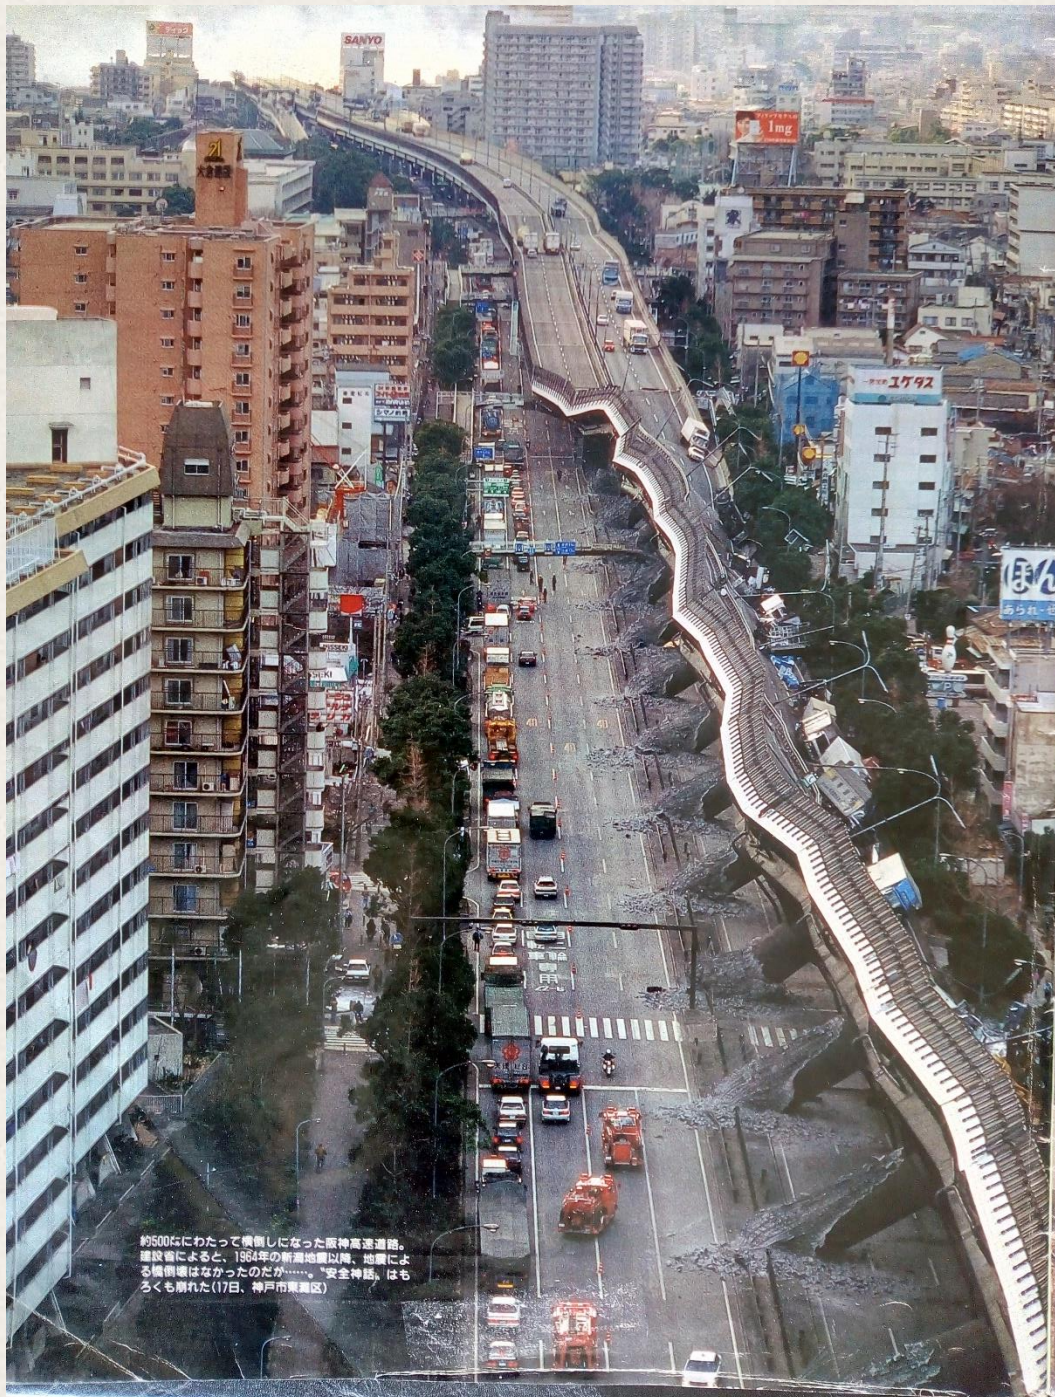
**1995 Kobe Depremi,  
Taşıyıcı Kolonlarda  
Makaslama/Burulma  
Yenilmesi**

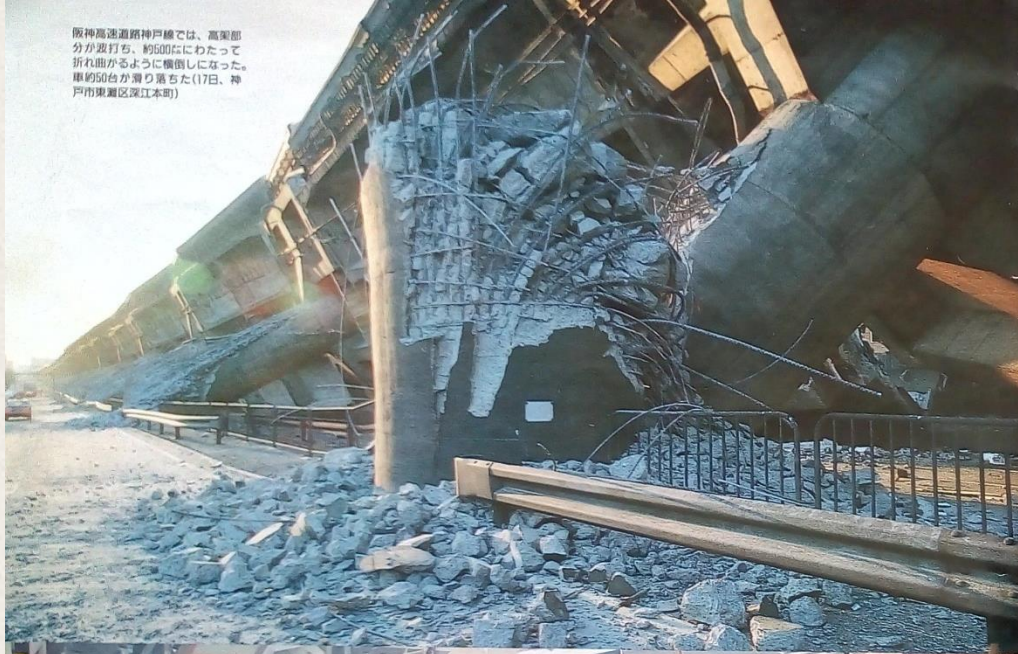
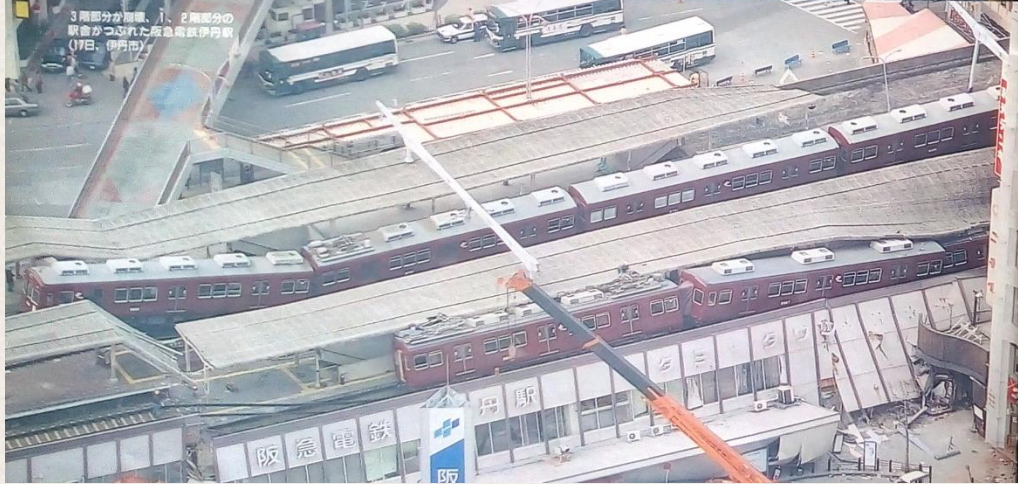
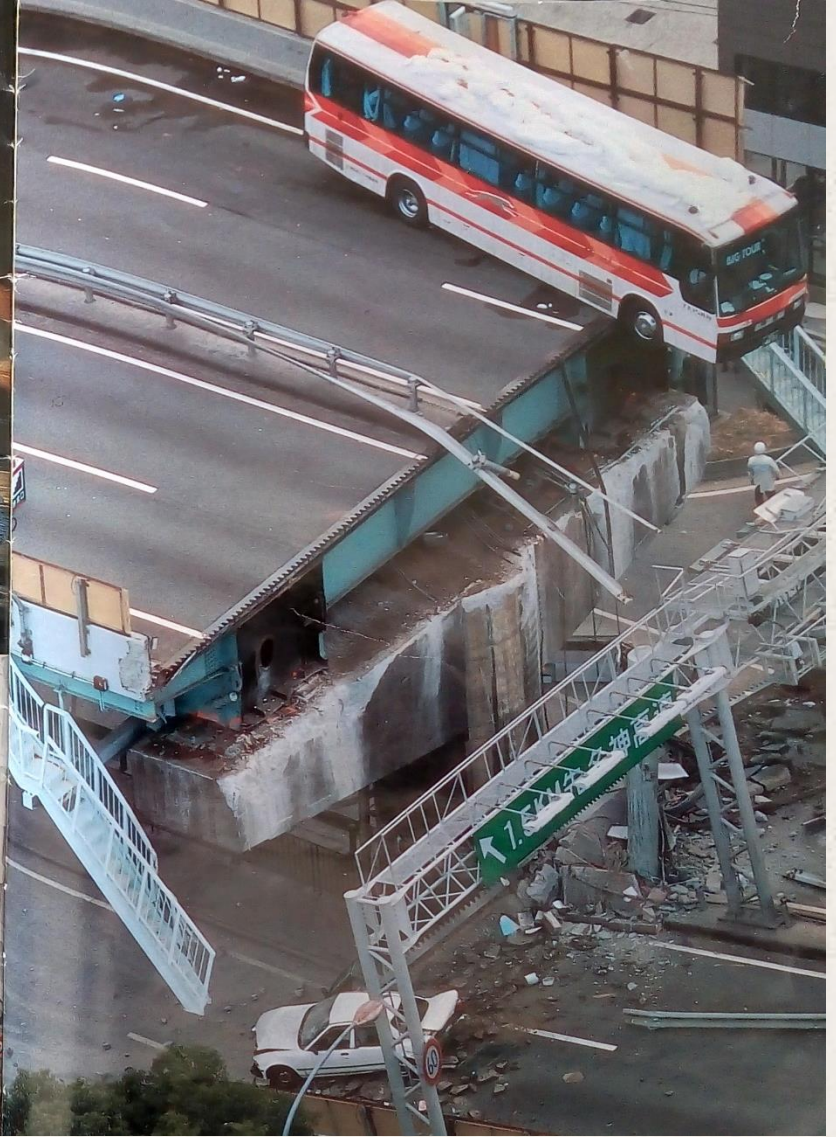
# Kolon Yenilmesi Yakın Plan Görüntüsü
